# Inspection Report

**Jane Doe  
130 5th St. NE  
Carrollton, OH 44615**

**GENERAL INFORMATION**Main entry faces: **North**Estimated Age: **90-100**Type Structure: **Two Story Single Family Home**Stories: **2**Type Foundation: **Basement**Soil condition: **Dry**Weather: **Overcast**Date: **6/10/2019**Unit occupied: **yes**Attendees: **Buyer**Bedrooms: **5**Vehicle Garages: **0**Approx. Sq Footage: **2112**Full Baths: **1**Half Baths: **1**3/4 Baths: **1**Temp: **71**Time: **10:18:50 AM**Client present: **yes**

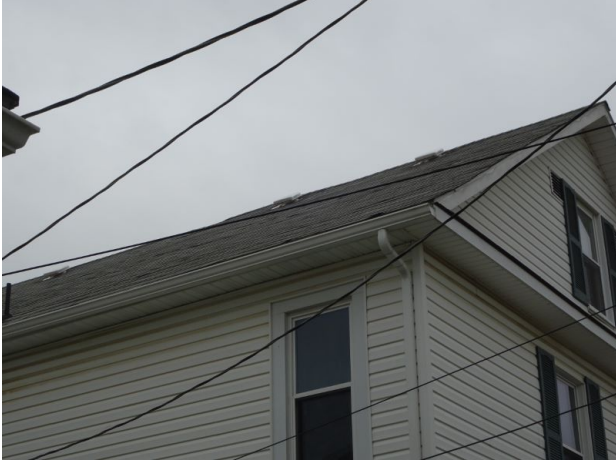
#R1

- Asphalt shingles beginning to curl on main roof. Recommend reputable contractor. (see photo 1).
- Broken shingle over left side upstairs access. Recommend reputable contractor. (see photo 2).

Shingles starting to curl.

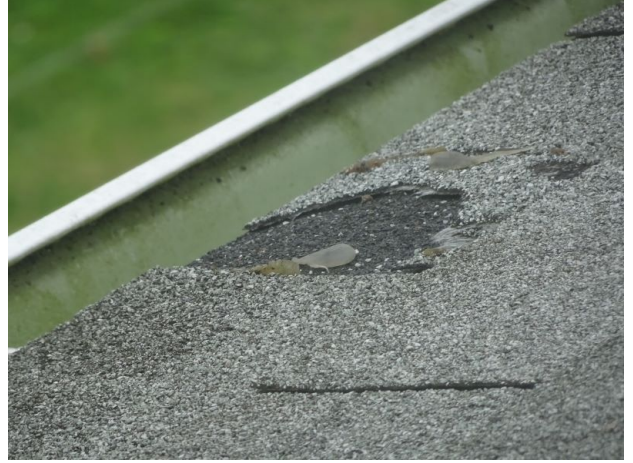
#R2

Broken shingle over side stairs.

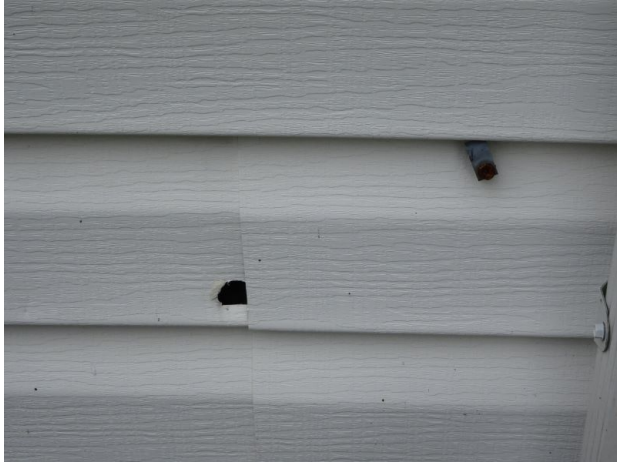
#EX1

1. Holes in siding and broken J channel on left side. Various holes in all sides of the house from past cables, attachments. This will allow for water and pest infestation. Recommend a reputable contractor. (see photos 1, 2).

Holes in siding.

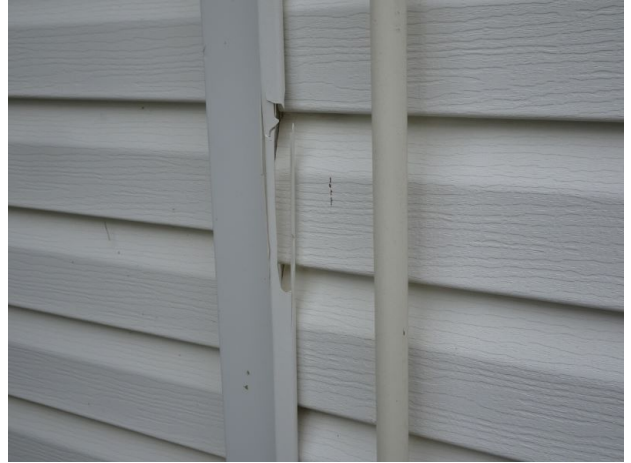
#EX2

Broken J channel.

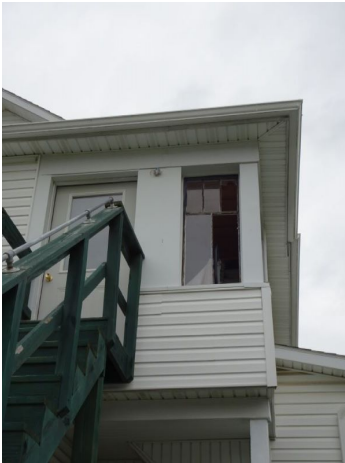
#EX3

2. **SAFETY HAZARD.** Upstairs back porch windows are broken. This may cut someone. Recommend reputable contractor. (see photo 3).

Broken window.

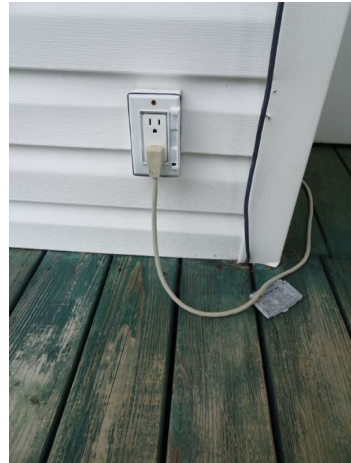
#EX4

3. **SAFETY HAZARD.** Back deck electrical outlet has broken cover. This will allow for shock or worse. Recommend cover replacement. (see photo 4).

Broken outside outlet cover.

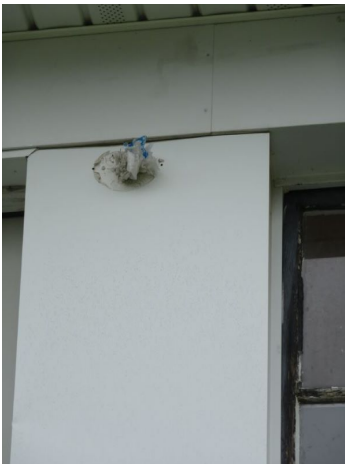
#EX5

4. Hole from missing exterior light fixture outside upstairs back porch. This will allow water and pest infestation. Recommend reputable contractor. (see photo 5).

Missing outside light fixture.

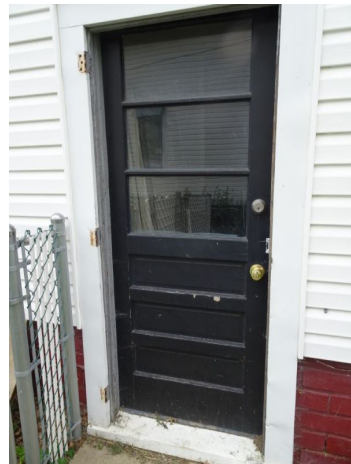
#EX6

5. **SAFETY HAZARD.** Front, left and rear porch entry doors are wooden. Doors should be metal thermal fire rated doors. Recommend a reputable contractor. (see photo 6).

Wooden entry doors.

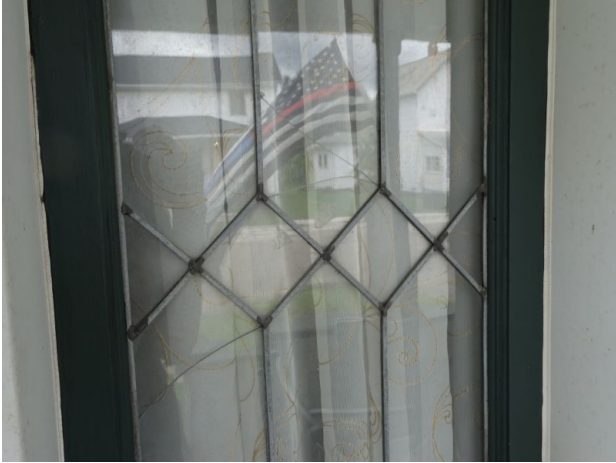
#EX7

6. **SAFETY HAZARD.** Leaded glass around front door entry is cracked. This may cut someone. Recommend reputable contractor. (see photo 7).

Cracked glass.

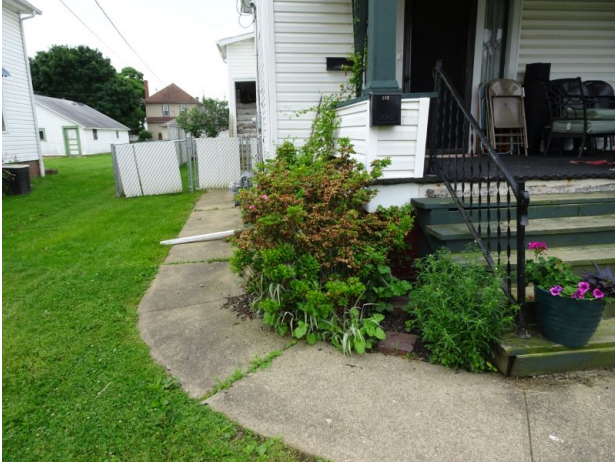
#GD1

1. Vegetation touching both left and right front porch. This will allow for pest infestation, mildew and fungus growth. Recommend trimming back vegetation 2-3' from house. (see photos 1, 2).

Vegetation touching house.

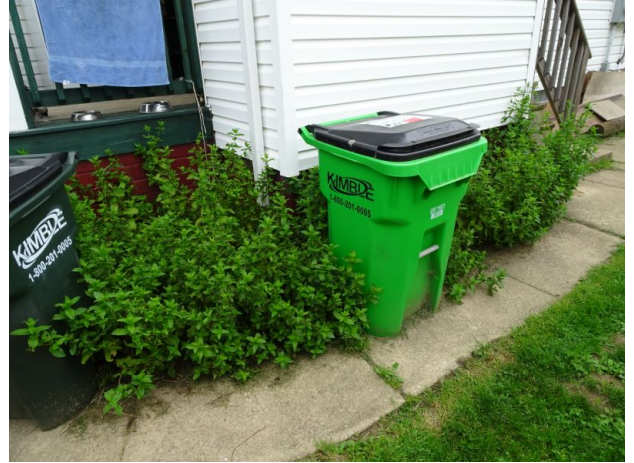
#GD2

Vegetation touching house.

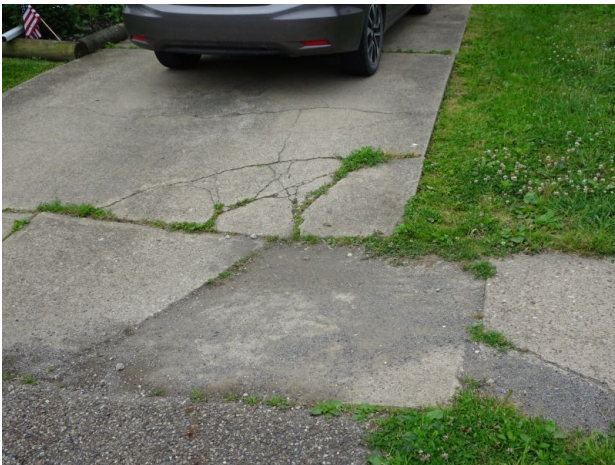
#GD3

2. **SAFETY HAZARD.** Concrete driveway is deteriorating and walkway is sinking. These are trip hazards. Recommend reputable contractor. (see photo 3, 4).

Driveway deteriorating.

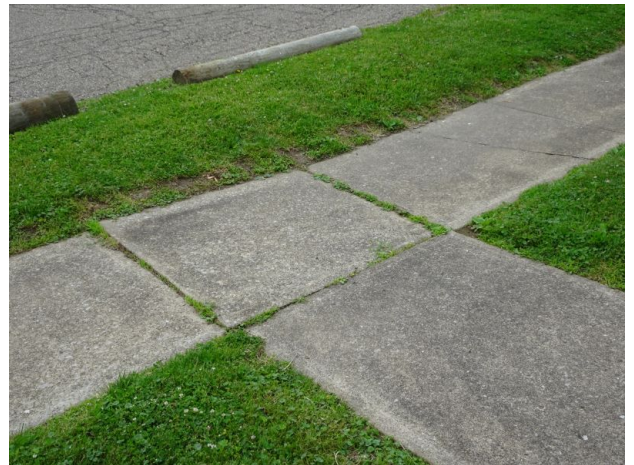
#GD4

Sidewalk sinking.

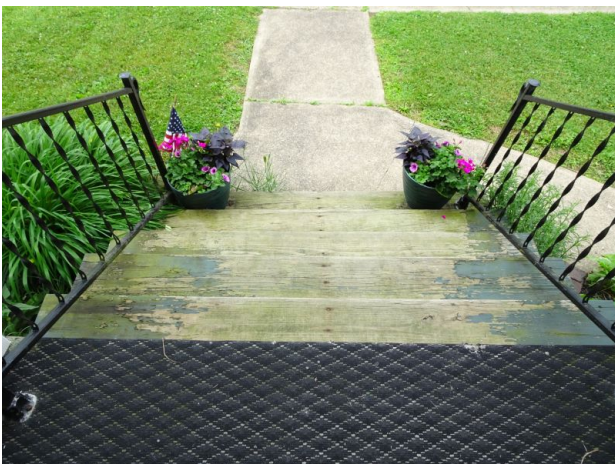
#GD5

3. **SAFETY HAZARD.** Front step handrails are loose. This is a fall hazard. Recommend a reputable contractor. (see photo 5).

Handrails are loose.

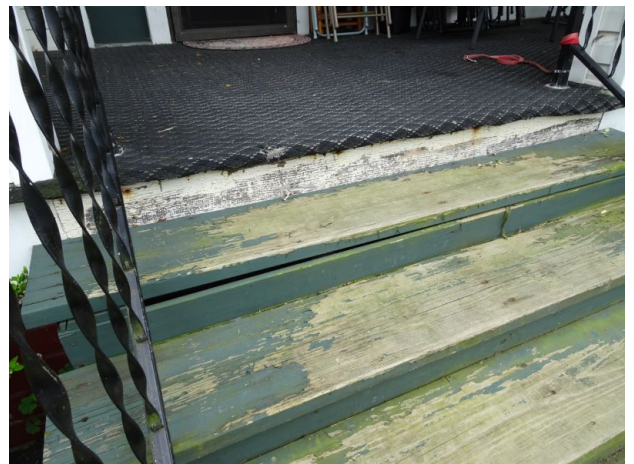
#GD6

4. Front porch steps and side steps have chipped paint. Recommend maintenance stain or paint. (see photo 6, 7).

Front steps need stain/paint.

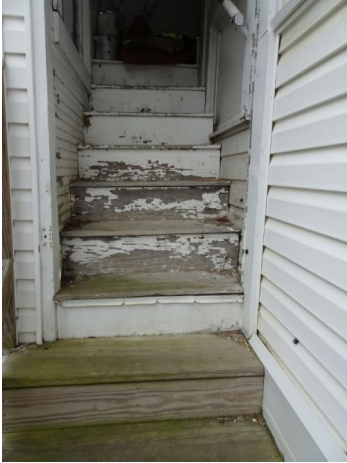
#GD7

Side steps chipped paint.

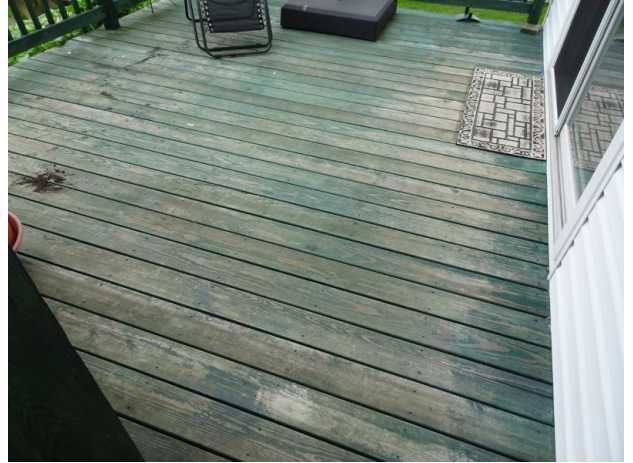
#GD8

5. Back deck has faded stain. This may allow for water penetration into wood. Recommend maintenance stain or paint. (see photo 8).

Back deck needs stain/paint.

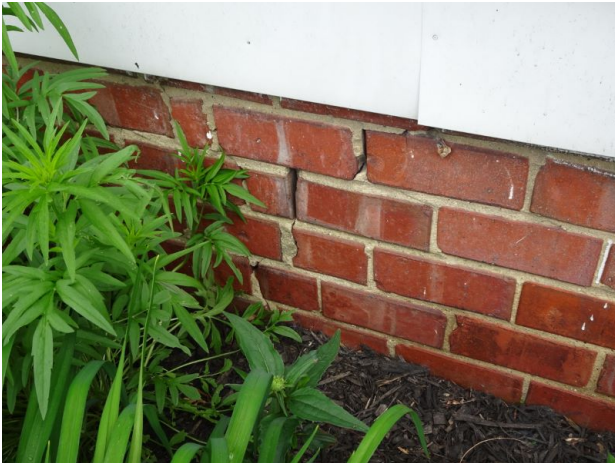
#GD9

6. Settlement crack in front porch foundation. Recommend filling in with concrete caulking.. (see photo 9).

Settlement crack.

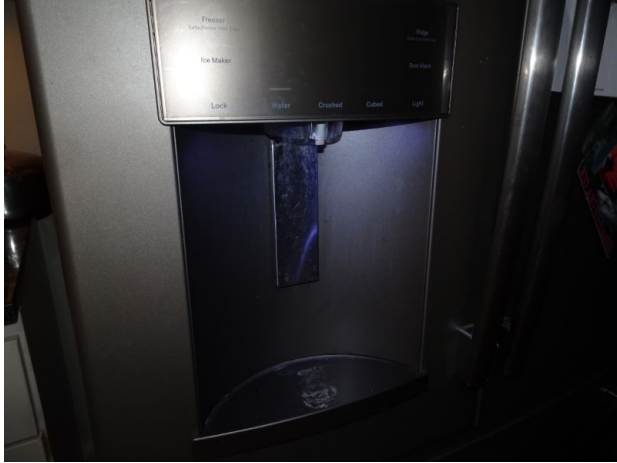
**#K1**

1. Ice maker in refrigerator does not work. Recommend reputable contractor. (see photo 1).

**Icemaker does not work.**

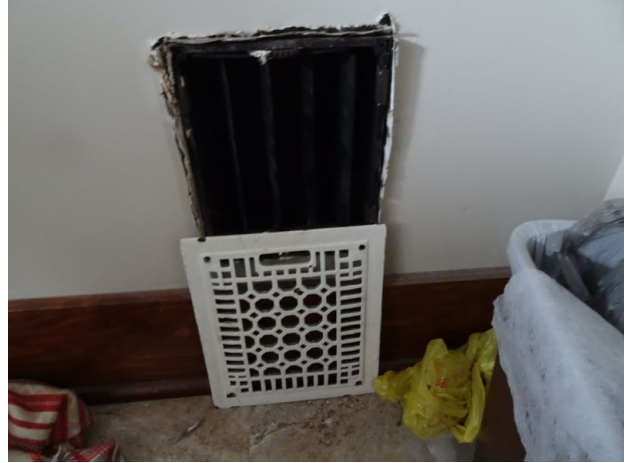
**#K2**

3. **SAFETY HAZARD.** Laundry HVAC register cover was unattached. Sharp metal edge may cut someone. Recommend reattachment. (see photo 2).

**HVAC register cover unattached.**

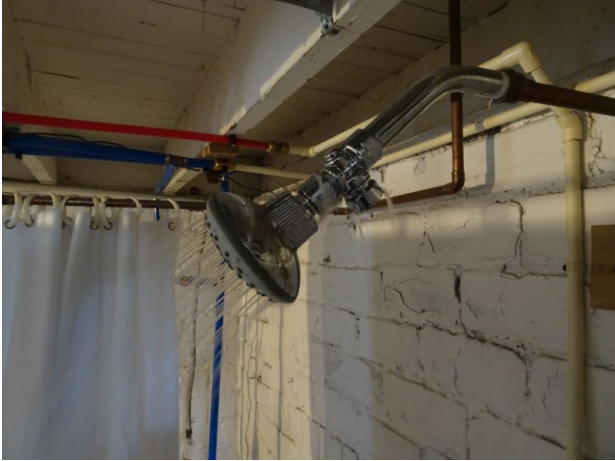
#B1

1. Basement shower head leaks at fitting. Recommend reputable licensed plumbing contractor. (see photo 1).
2. Basement shower light does not working. Recommend reputable licensed electrical contractor. (see photo 2).
3. Downstairs bath window opener/closer is broken. Recommend reputable contractor. (see photo 3).

Basement shower head leaking at fitting.

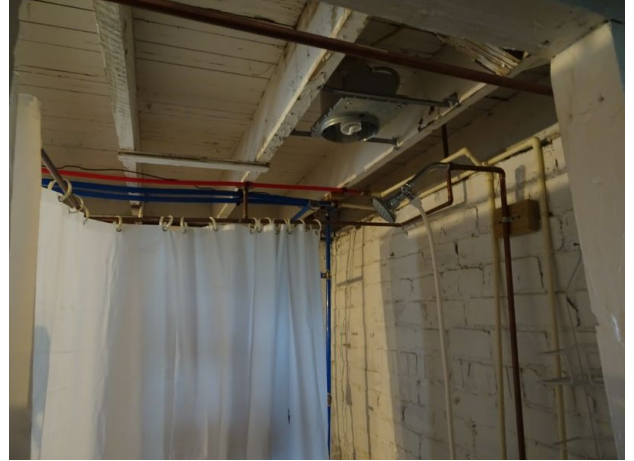
#B2

Basement shower light not working.

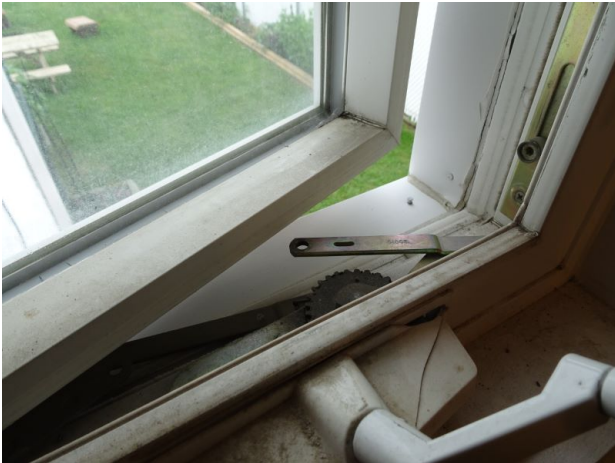
#B3

Window closer is broken.

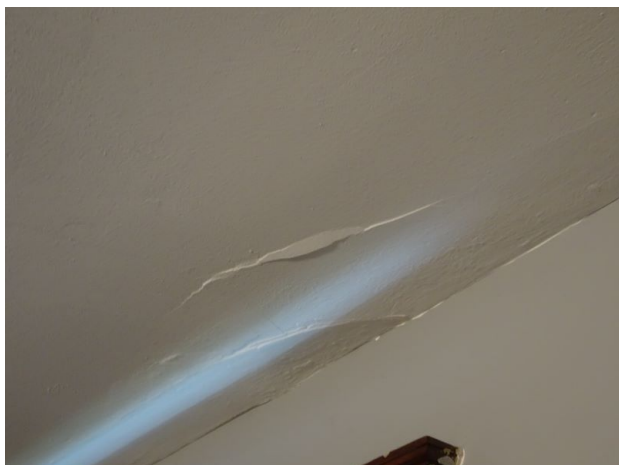
#IR1

1. Front right (grey) bedroom ceiling shows signs of bulging plaster. Continue to monitor. (see photo 1).
2. Upstairs hallway built-in cabinet door sticks and is difficult to open/close. Recommend maintenance. (see photo 2).
3. **SAFETY HAZARD.** All bedrooms have unattached HVAC register covers. Sharp metal edges could cut someone. Recommend reattachment. (see photo 3).
4. **SAFETY HAZARD.** Front entrance leaded windows are cracked. This may cut someone. Recommend reputable contractor. (see photo 4).
5. **SAFETY HAZARD.** Dining room built-in cabinet has missing glass panel. This may cut someone. Recommend reputable contractor. (see photo 5).
6. **SAFETY HAZARD.** Attic has no smoke detector. This is a fire safety requirement. Recommend installation. (see photo 6).

Front right bedroom ceiling bulging.

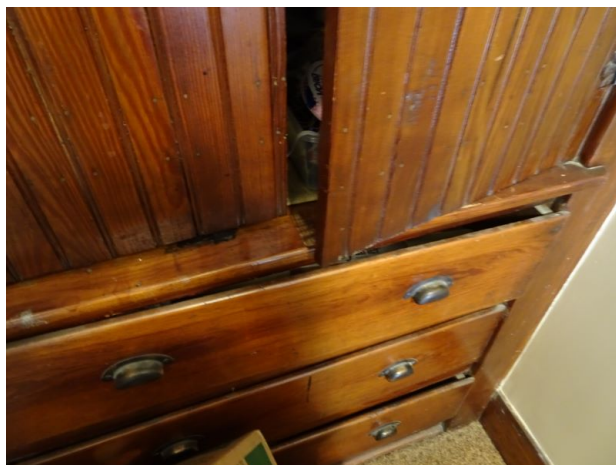
#IR2

Upstairs built-in cabinet door sticks.

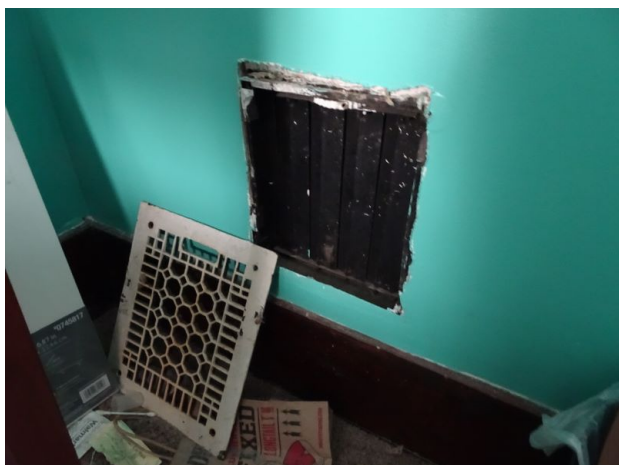
#IR3

Middle bedroom register cover unattached.

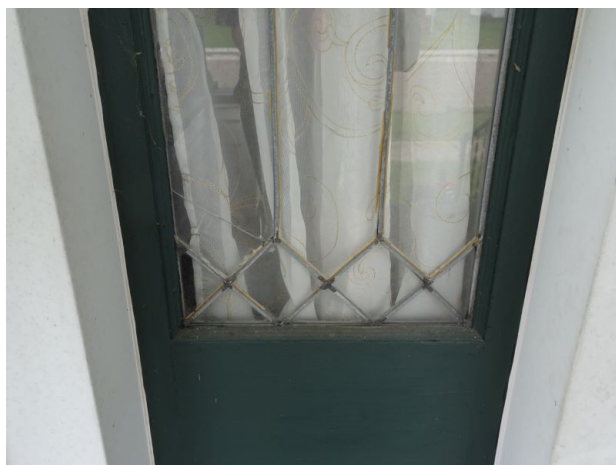
#IR4

Entranceway cracked glass.

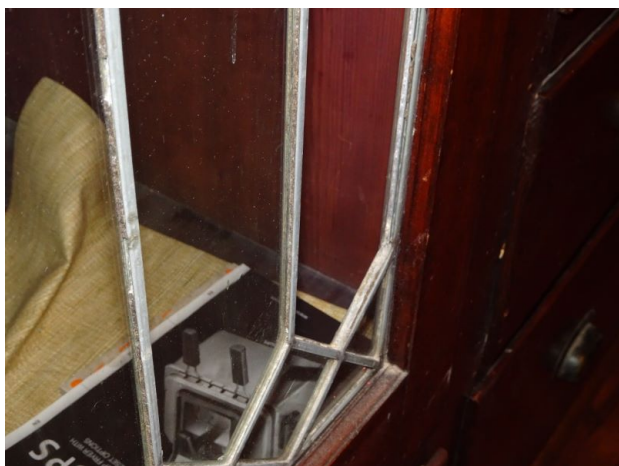
#IR5

Missing glass.

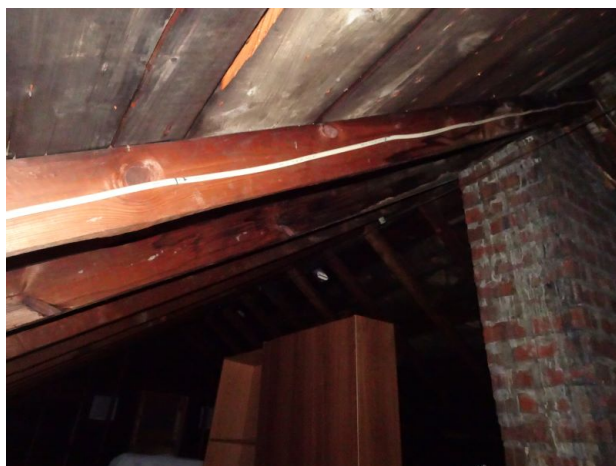
#IR6

No smoke detectors in attic.

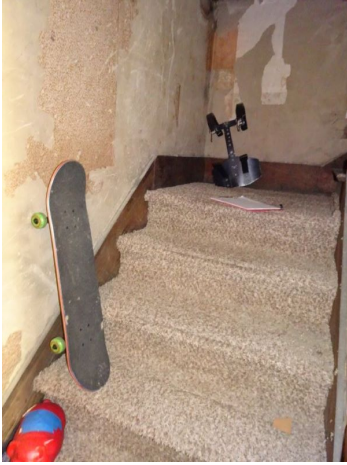
#AT1

1. **SAFETY HAZARD.** Attic stairs have no hand railing. This is a fall hazard. Recommend reputable contractor. (see photo 1).
2. **SAFETY HAZARD.** Exposed wiring on left side knee wall. This is a fire hazard and will allow for shock or worse. Recommend reputable licensed electrical contractor. (see photo 2).

No hand railing.

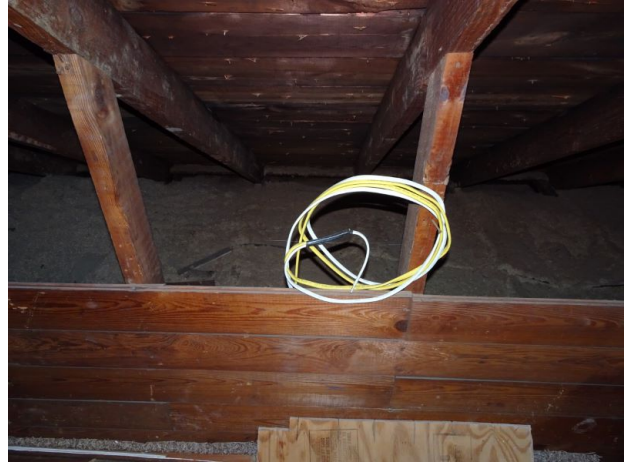
#AT2

Exposed wiring.

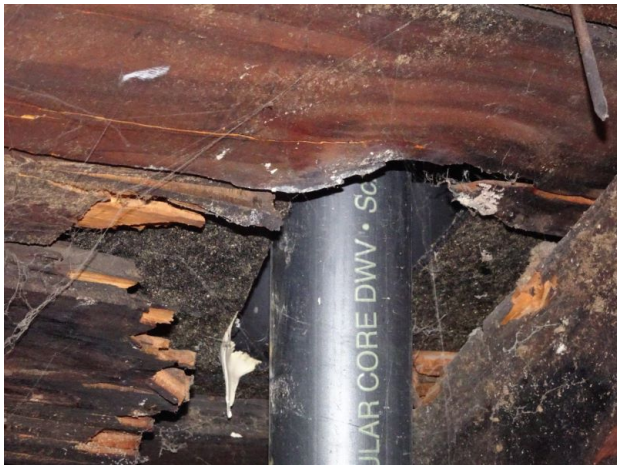
#AT3

3. Plumbing vent is not properly sealed around roof penetration. This will allow water penetration. Recommend reputable contractor. (see photo 3).
4. Damaged sheathing boards where plumbing vent penetrates roof. This will allow water penetration. Recommend reputable contractor. (see photo 3).

Bathroom vent not properly sealed. Wood sheathing damaged.

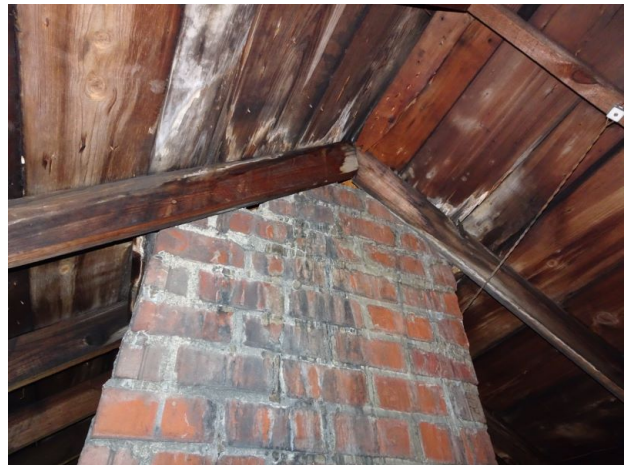
#AT4

5. Signs of old water damage around chimney. Chimney is now capped over by roof. Monitor for any new water leaks. (see photo 4).
6. **SAFETY HAZARD.** Back window has no hinges and is fastened in place with nails and wire. This will not allow for egress in case of fire. Recommend reputable contractor. (see photo 5).

Old water damage.

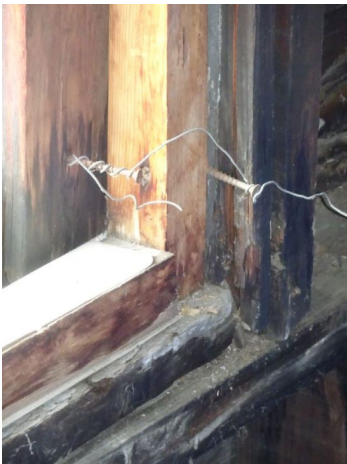
#AT5

Back window fastened with screws and wire.

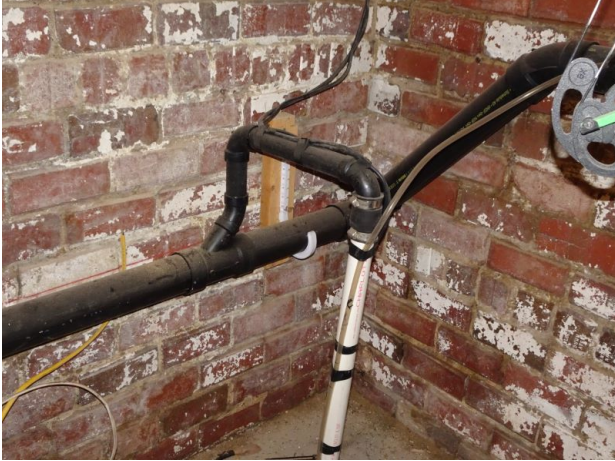
#F1

1. **SAFETY HAZARD** Sump pump connected directly into sanitary sewer line. This may result in sewage backing up through the line and overflowing into home. Recommend reputable licensed plumbing contractor. (see photo 1).
2. No insulation along rim joist. Recommend insulation installation. (see photo 2).

Sump pump connected to sanitary sewer line.

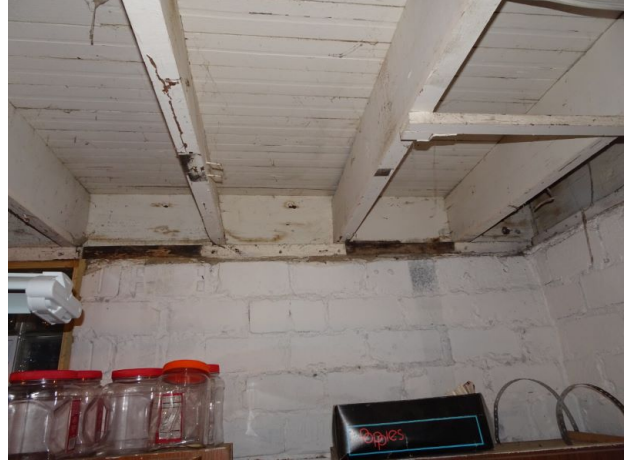
#F2

No insulation along rim joist.
